**LTPP Seasonal Monitoring
Program**
Site Monitoring Suspension
Status Report
Section 231026
East Dixfield, Maine

SEASONAL MONITORING PROGRAM SUSPENSION STATUS REPORT MAINE SECTION 231026

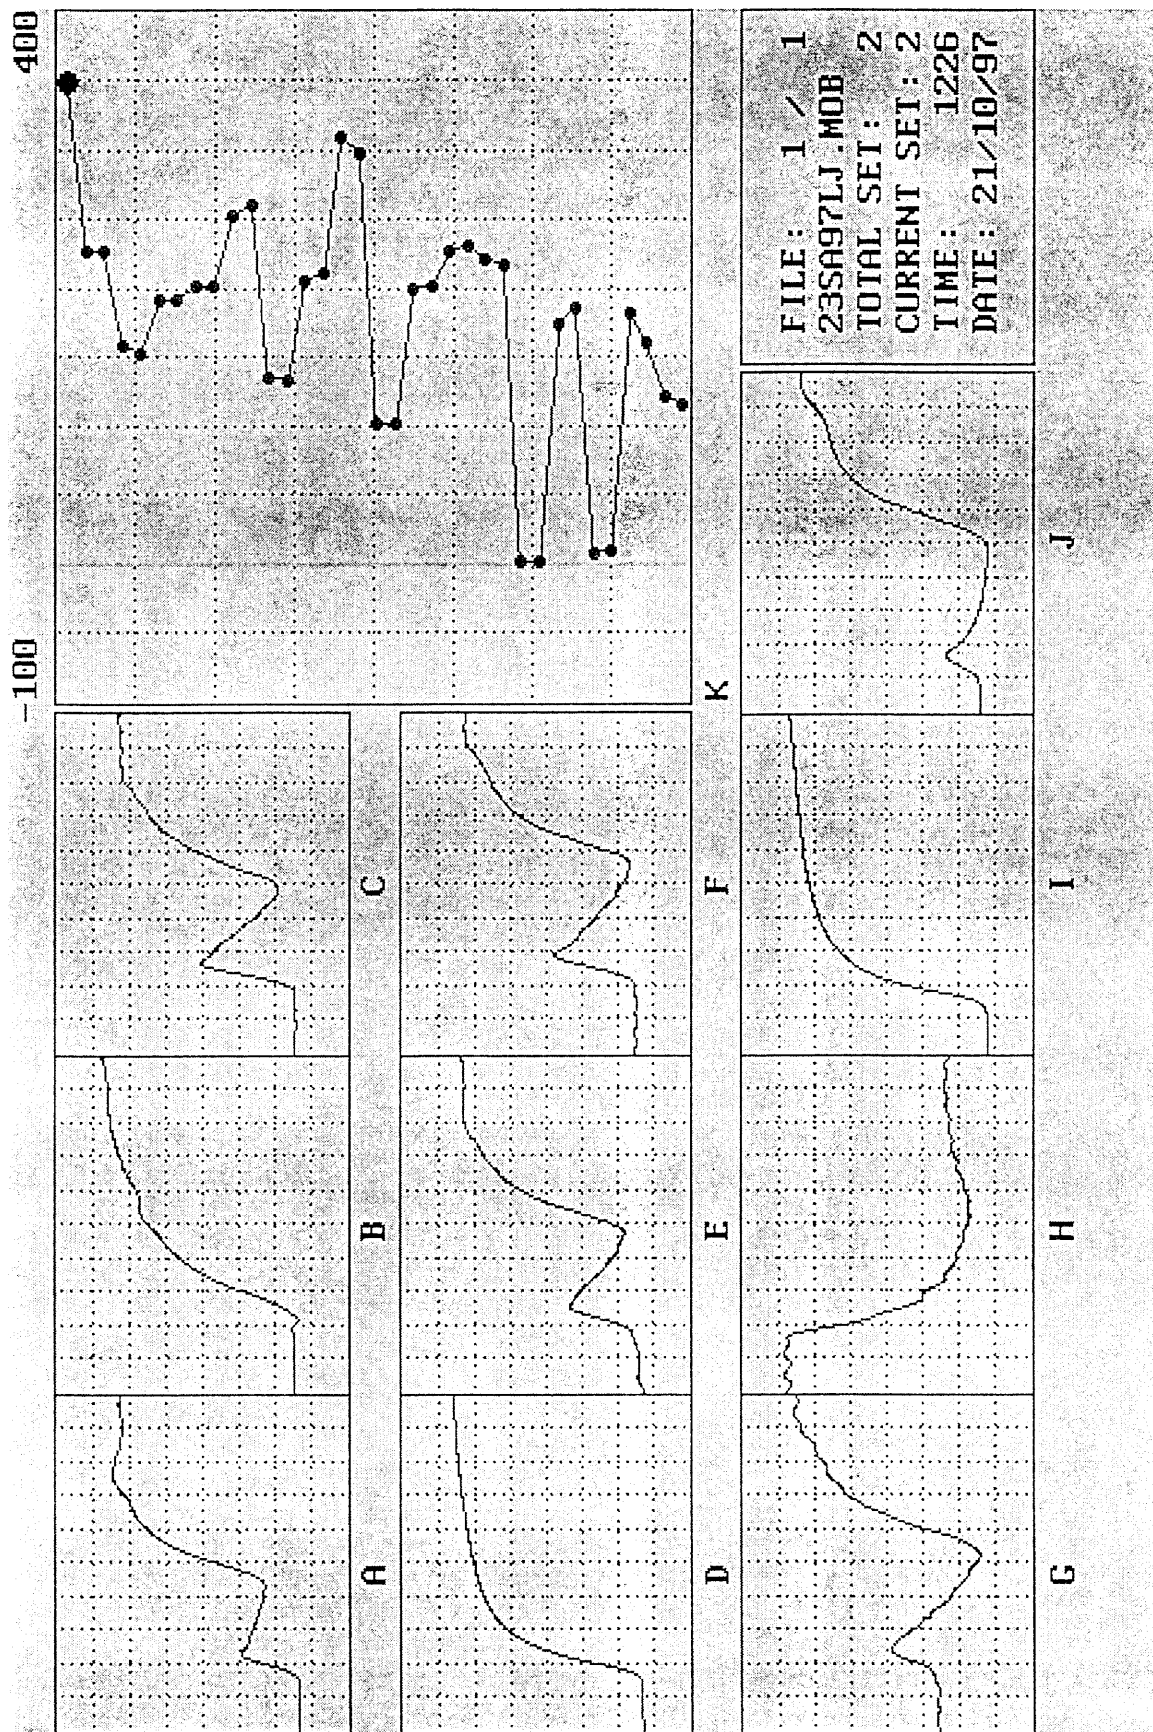
Figure 2: Second Set of Mobile Data Collected on October 21, 1997

At the time of suspension, TDR sensors #2, 4 and 9 were not functioning. TDR sensor #4 was not functioning at the beginning of Round 2 data collection activities in October 1996. Figure 2 shows the last set of mobile data collected before the site was suspended. Other than TDR sensors #2, 4 and 9, there were no unresolved problems with any of the sensors at the time of site suspension activities. The plots from ONSFIELD, MOBFIELD and SMPCHECK follow expected trends and produce expected values.

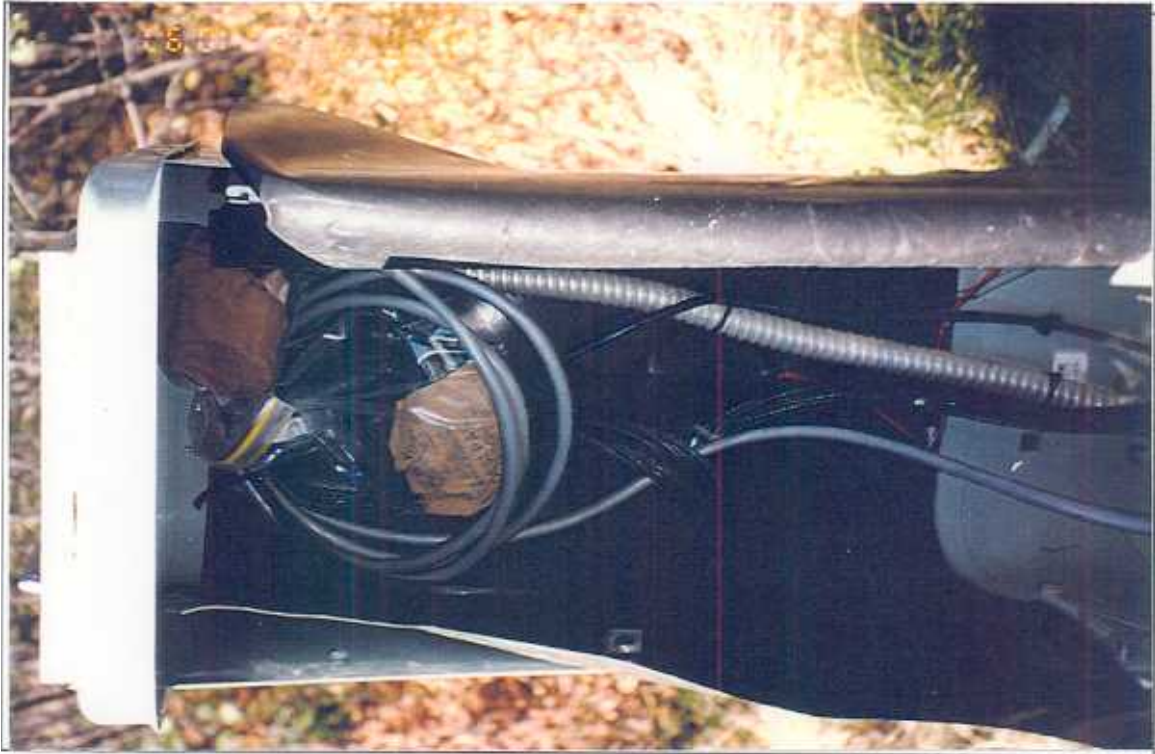
Inside Equipment Cabinet, Seasonal Site 231026 - Oct. 1997, after Suspension Activities

The solar panel was disconnected. After all wires to the control panel were disconnected, the panel was detached from the equipment cabinet along with the CR10 datalogger, terminal strip and battery pack. The TDR cables, resistivity cable and MRC lead wires were sprayed with an anti-corrosive compound and sealed with desiccant packs in air tight bags. All cables/wires were hung up high inside the equipment cabinet. After the last piezometer reading was recorded, the pipe was cleaned and sealed with grease. The access cover and seat were cleaned and lubricated before being covered and brought up to grade with native soil.

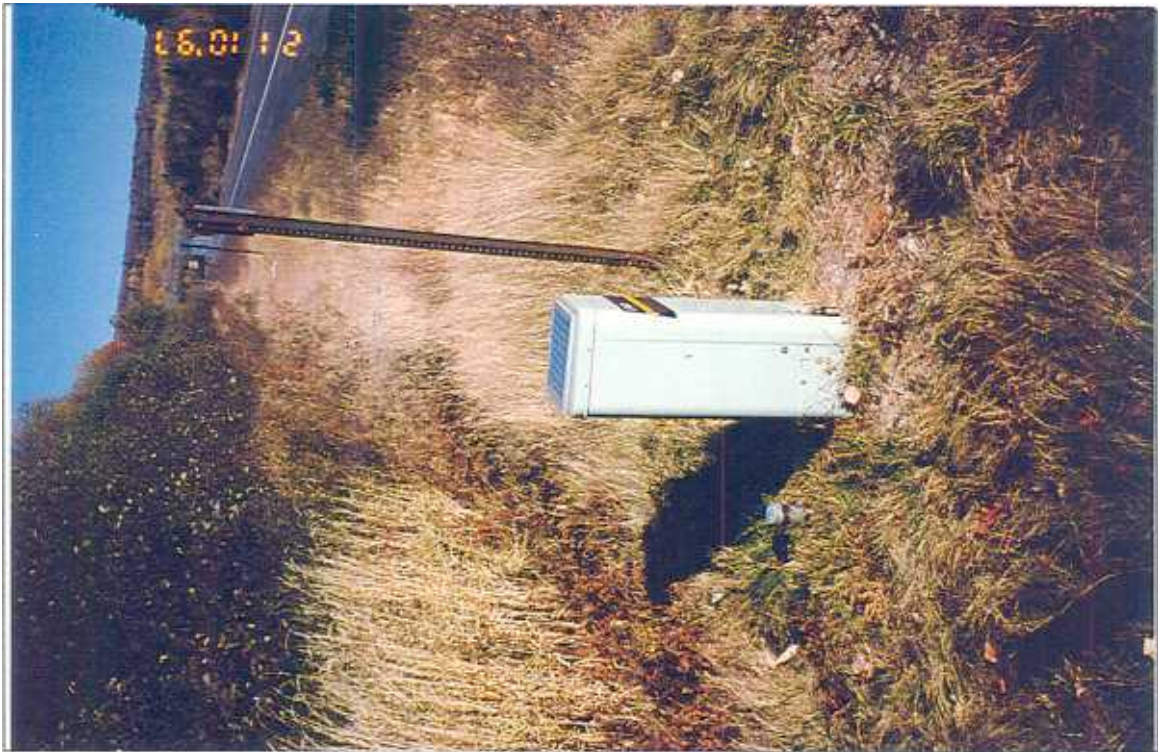
Equipment Cabinet, Lower portion of inst. pole, Seasonal Site 231026 - Oct. 1997, after Suspension Activities

The air temperature probe, tipping bucket, and the upper part of the support pole were dismantled. The lead wires from the air temperature probe and tipping bucket were removed from the cabinet and sprayed with an anti-corrosive compound. A galvanized wire was left in the underground conduit that runs between the support pole and equipment cabinet and will be used to pull the instrumentation wires back if data collection is re-initiated at this site. The bottom part of the support pole was cleaned and lubricated before installing the end cap.
